Inspection Report

Minerals Regulatory Program

Mine Name: Towers Sand and Gravel
Operator Name: C. E. Butters Realty and Construction

Permit number: S0570004
Inspection Date: April 9, 2008
Time: about 11:30 AM to 1:30 PM

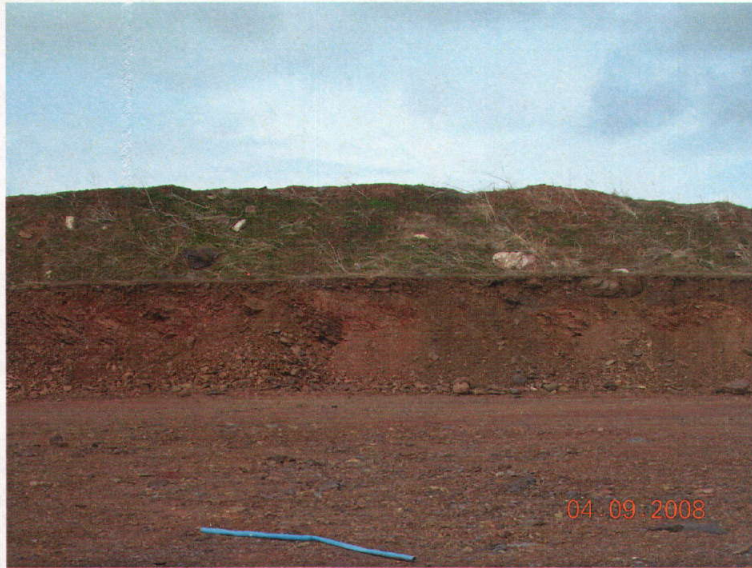
There is an area above the main part of the mine from which clay has been extracted (Photo 1).

Photo 1. Clay pit—about one acre—to the north of the main part of the mine.

The clay pit needs to be included as part of the disturbed area.

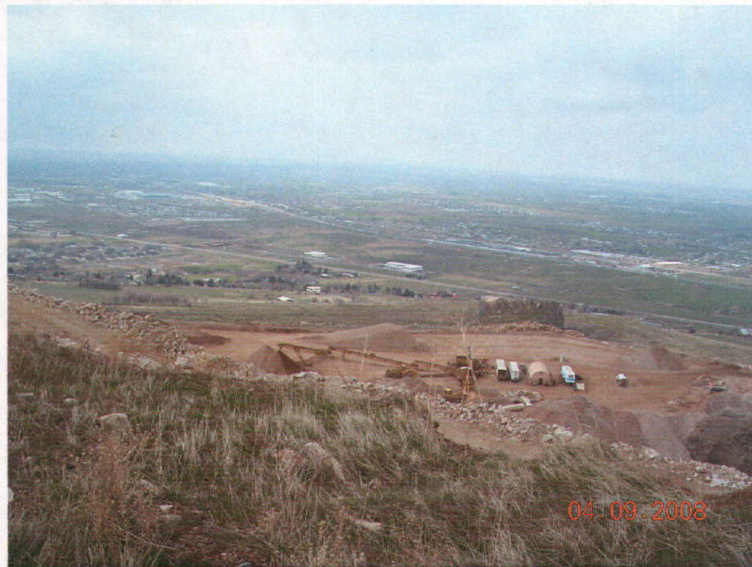
Photo 2. Overview of some of the crushing and screening operations.

The Division should send a letter giving the operator a deadline for submitting a Notice of Intention to Commence Large Mining Operations. All of the crushing and screening operations and the scale house need to be included in the disturbed area. It may be possible to exclude areas being mined strictly for sand and gravel.

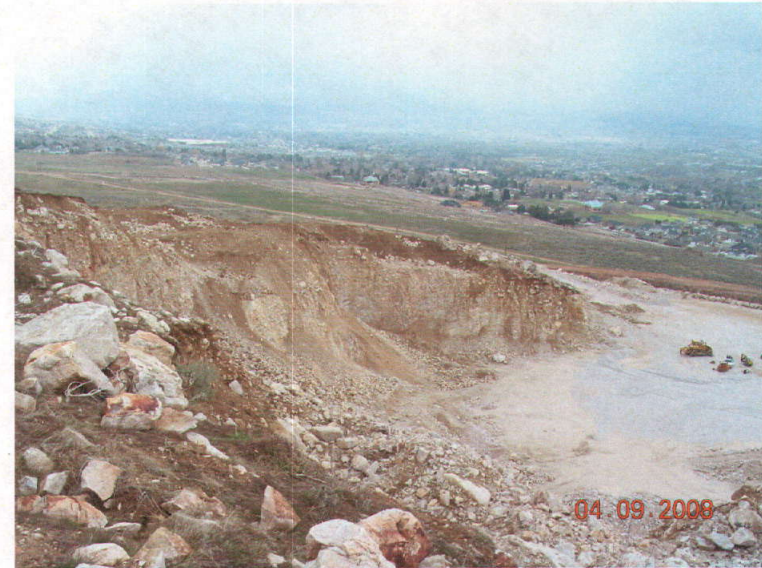
Photo 3. A portion of the highwall and adjacent pad.

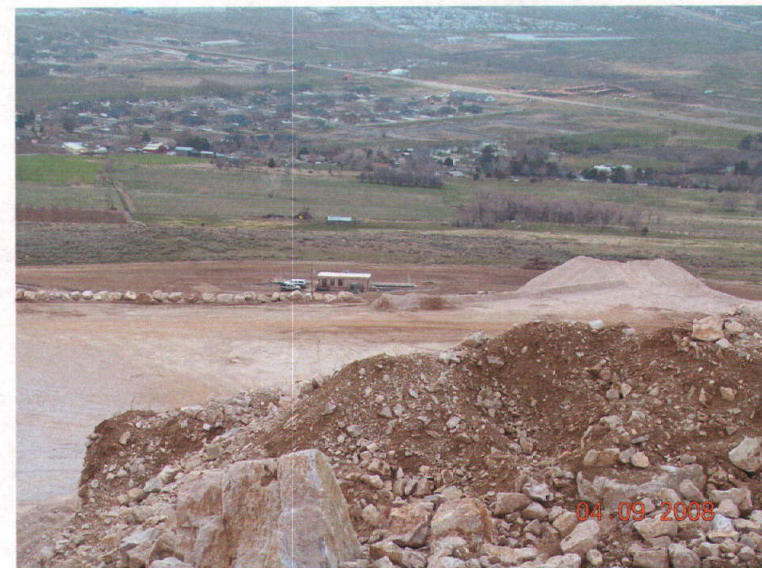
Photo 4. Near the center of the photo is a scale house on a different level than the pad. To the right of the scale house is a large pile of gravel and smaller-sized material.

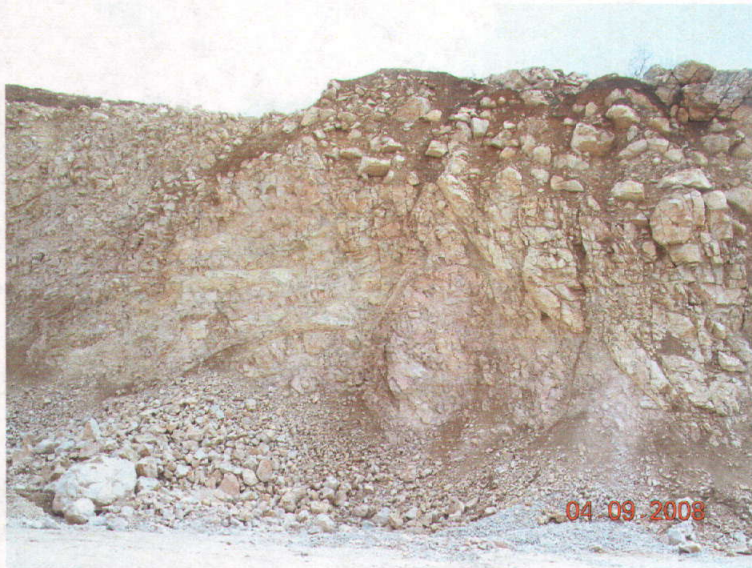
The operator is mining some unconsolidated alluvial sand and gravel, but as far as I could determine, it appeared the majority of the operation is in consolidated or partially consolidated rock that was not deposited by sedimentary processes. Photo 5 shows one type of deposit being mined. Near the surface, the rock is weathered and may not be fully consolidated, but it becomes more intact with depth.

Photo 5. The highwall. Note that it is nearly vertical.

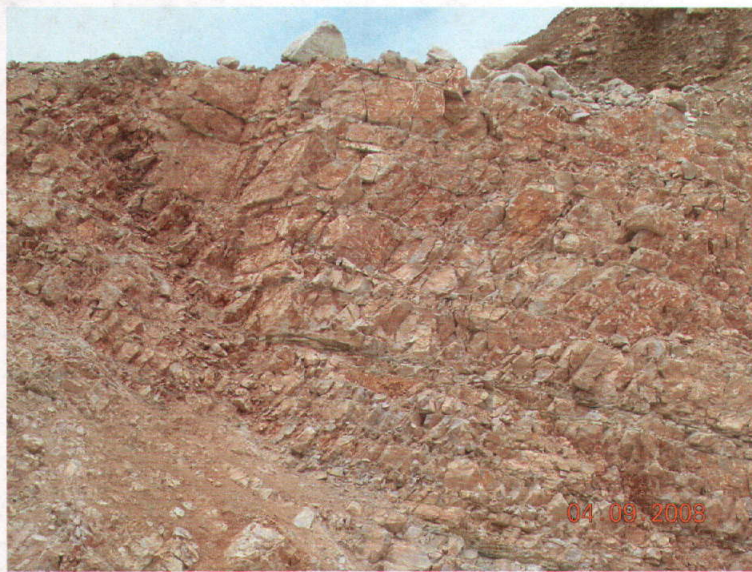
I agree with the conclusions of this report. Although the operator is mining some alluvial sand and gravel, the majority of the site has exposed highwalls which are clearly consolidated rock. At and near the surface, the rock is weathered to the point that it is not always fully consolidated, but this rock was not deposited by sedimentary process, does not meet the size criteria for gravel, and is not in a matrix of alluvial sand and gravel as would be required for rock aggregate.

Photo 6. Another view of the highwall. This is clearly not sand and gravel.

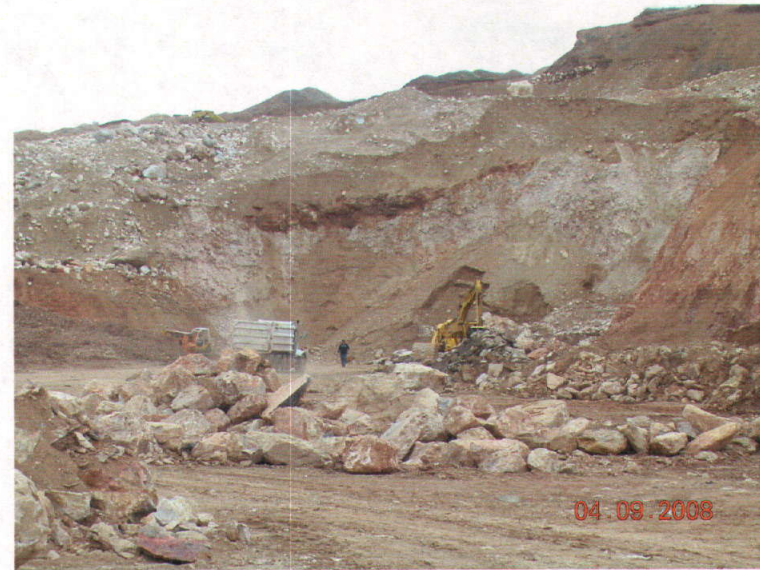
There are some parts of the mine where the operator is extracting material meeting the definitions of sand and gravel in the rules. Extraction of this size and nature of material is exempt from regulation by the Division.

Photo 7. This shows an area from which the operator is mining sand.

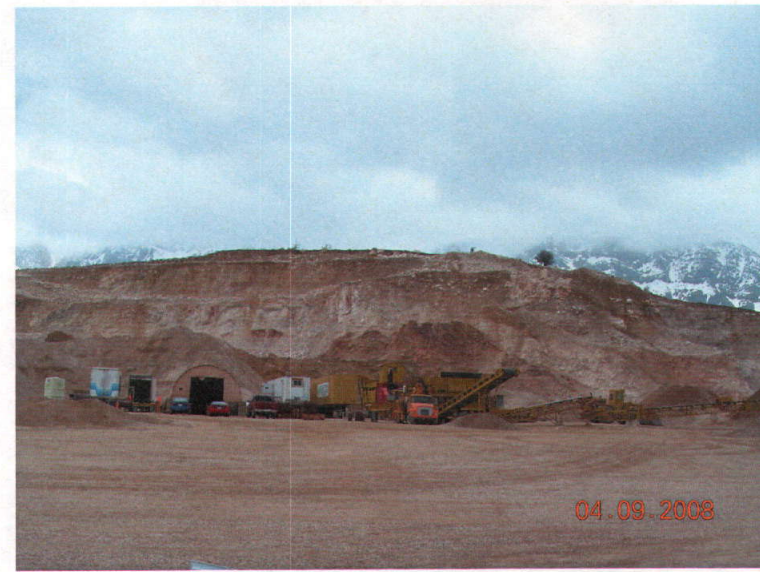
Photo 8. Another view of the crushing and screening operations and the highwall.
